GERROA SAND RESOURCE

ANNUAL REVIEW

Period 01 July 2023 – 30 June 2024

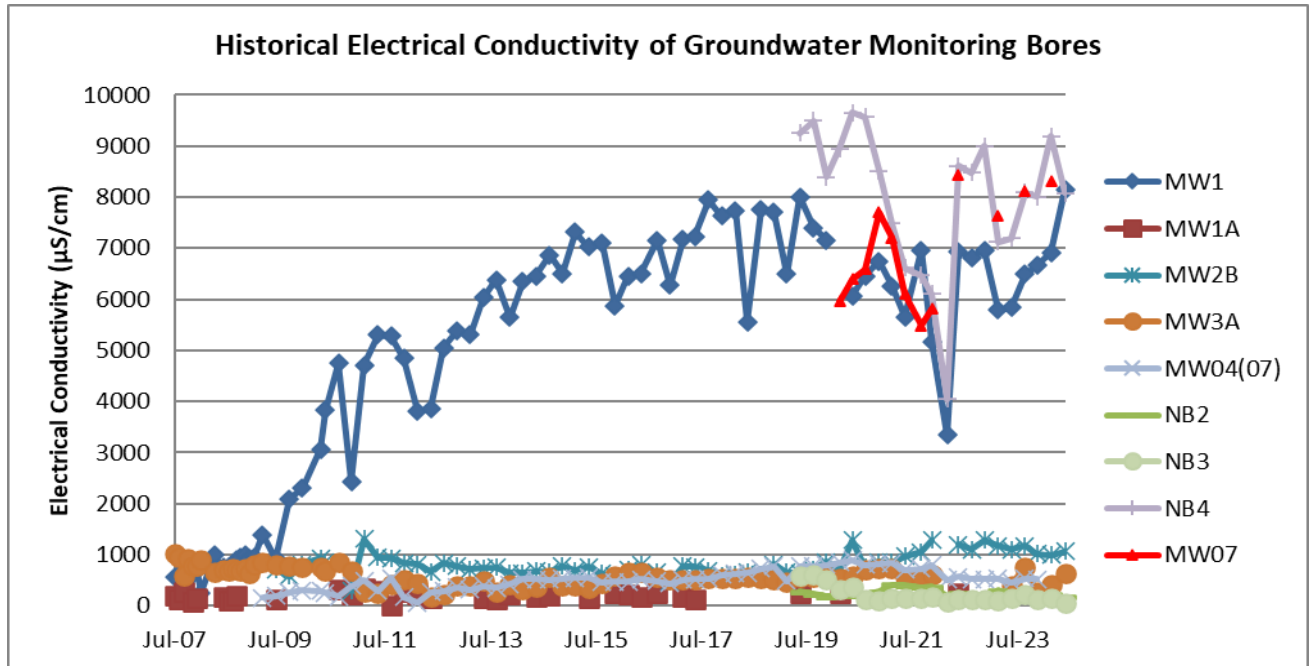
The results over the 12-month period show variability in the Electrical Conductivity (EC) of the groundwater in the boreholes which is consistent with the long term pattern. Brackish groundwater in MW1 has been attributed to the Berry Siltstone aquifer to the southwest which continues to influence the groundwater quality in this bore. Meanwhile, brackish groundwater in bores NB4 and MW07 are influenced by tidal exchanges with the Crooked River estuary. With the exception of these three bores, the EC of all bores have remained with the objective levels, and are consistent with the historical ranges for the bores.

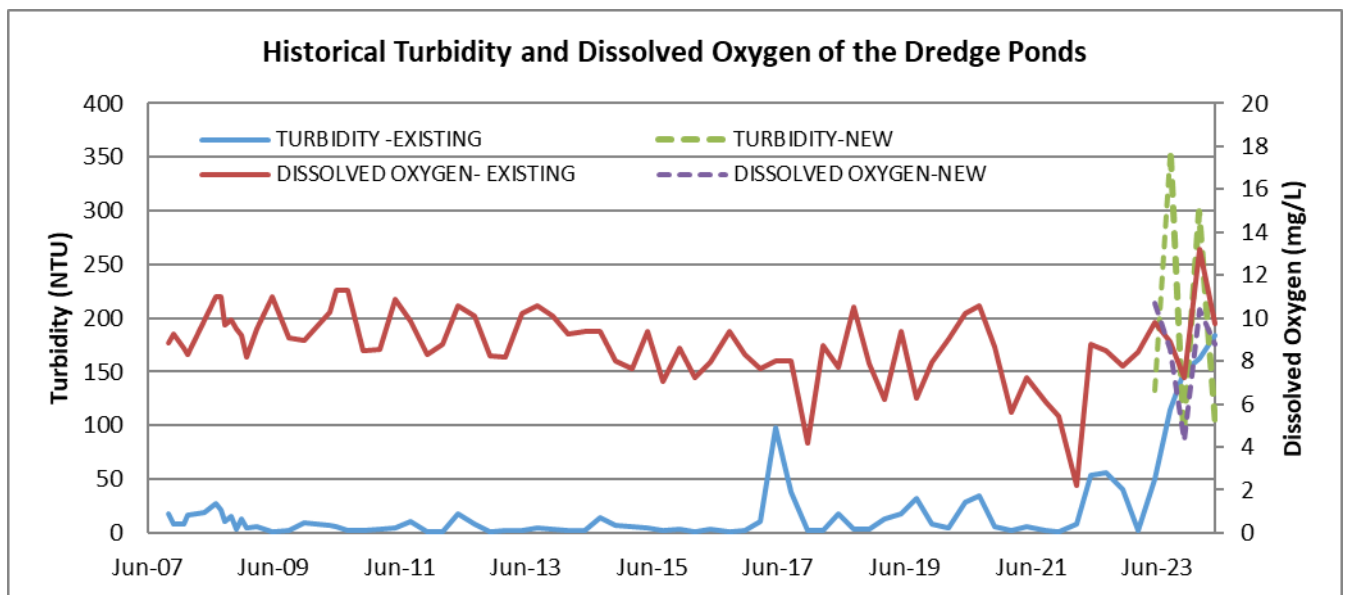
Turbidity and Dissolved Oxygen

The turbidity of both dredge ponds has varied during the current reporting period due to extraction within the new dredge pond with a higher proportion of fines. The sampling point is close to the outflow of the existing dredge pond, and also the active area of the new dredge pond which has also influenced these measurements. Dissolved Oxygen also continued to record significant variations in concentrations during the reporting period due to the recirculation of water between the dredge ponds.

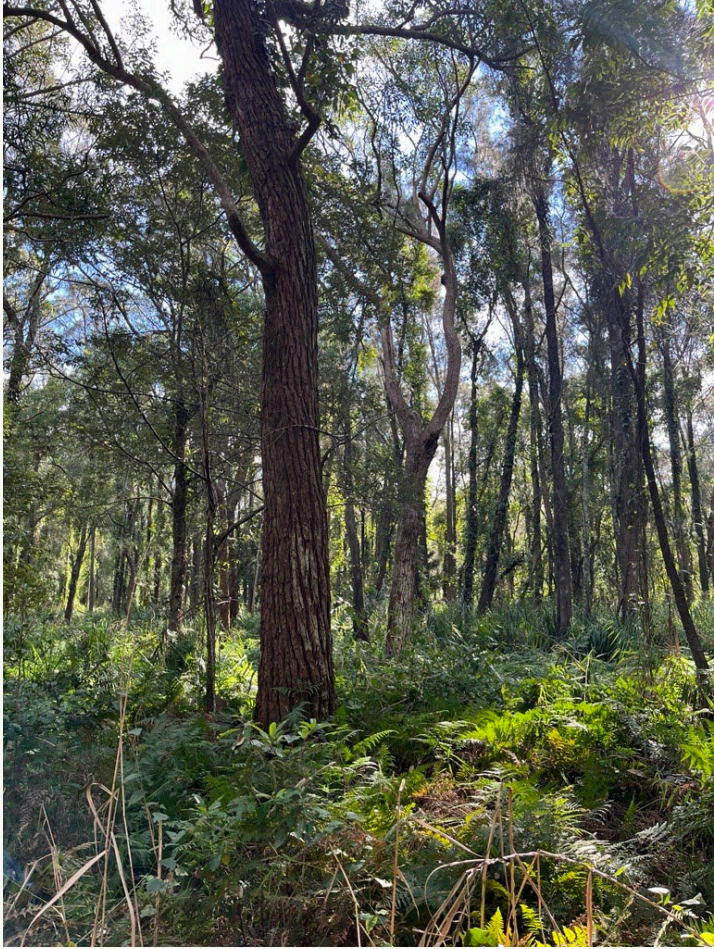
Zone	Location / description	Recommendations for ongoing works 2024/2025	Reference Images
Subzone 1.1	This is the main area of existing forest, extending from the southern to northern end of the property boundary.	<p>The northern corridor of subzone 1.1 appears to be in good condition. Fireweed (<i>Senecio madagascariensis</i>), Cobbler's Pegs (<i>Bidens pilosa</i>) and Rhodes Grass (<i>Chloris gayana</i>) were all recorded, mainly close to the edge of the dredge pond.</p> <p>The larger portion of 1.1 appears to be mostly high condition vegetation (pictured). Some tall stands of Giant Reed (<i>Arundo donax</i>) were recorded along the roadside and in lower lying areas in the eastern section (Plate 1). Large stands of Lantana (<i>Lantana camara</i>) were also observed, however for the most part these were also confined to roadside sections.</p>

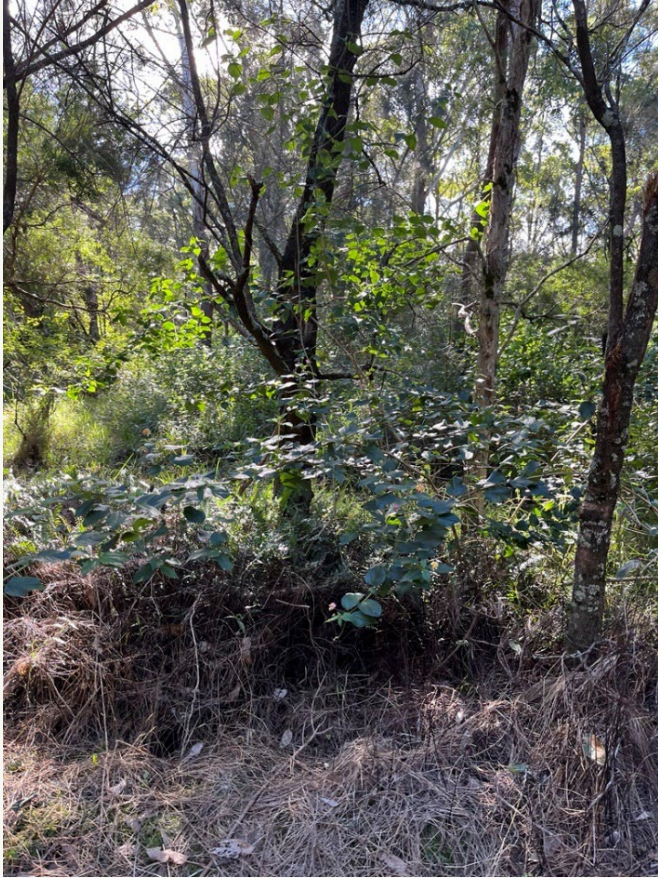
Zone	Location / description	Recommendations for ongoing works 2024/2025	Reference Images
Subzone 1.2	This subzone covers the forest around the eastern and southern sides of the old dredge pond.	<p>Dense Lantana (<i>Lantana camara</i>) still persists throughout this zone (pictured), particularly within the northern linear section of subzone 1.2. Continue to manage via cut and paint methods. Scattered Crofton weed (<i>Ageratina adenophora</i>) was also noted.</p> <p>The southern portion of this zone near the office appears to be in reasonable condition, however multiple individuals of Cassia (<i>Senna pendula</i>) were observed (Plate 2), and Moth Vine (<i>Araujia sericifera</i>) was seen beginning to overtake native trees.</p>

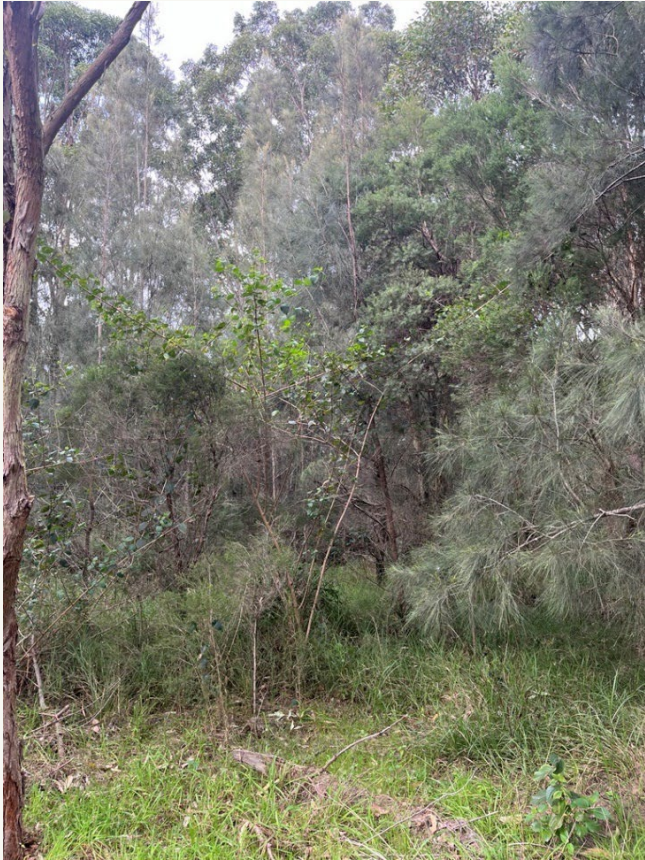
Zone	Location / description	Recommendations for ongoing works 2024/2025	Reference Images
Subzone 1.3	Covers the old bund wall. This subzone is located behind the site office and towards the front gate.	This subzone appears to be in relatively good condition, with weeds mainly confined to roadside patches (pictured). Lantana (<i>Lantana camara</i>) and Moth Vine (<i>Araujia sericifera</i>) (Plate 3) are the priority weeds in this area. Control using cut and paint methods. Fireweed (<i>Senecio madagascariensis</i>), Rhodes Grass (<i>Chloris gayana</i>) and Cobblers Pegs (<i>Bidens pilosa</i>) were also recorded along the roadside.

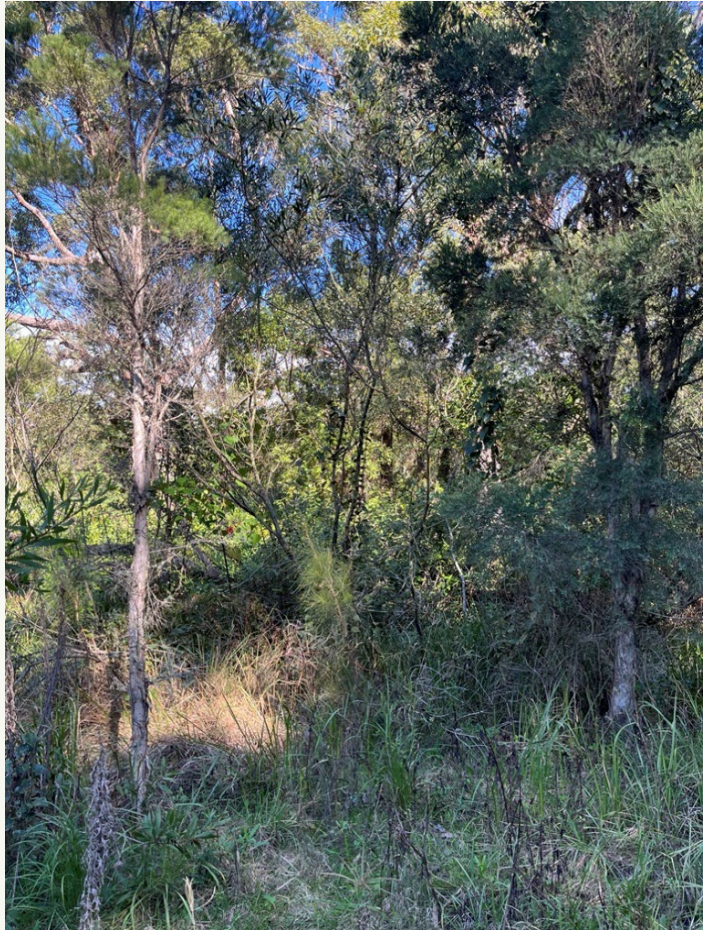
Zone	Location / description	Recommendations for ongoing works 2024/2025	Reference Images
Subzone 2A.3	<p>This area was revegetated early in the re-planting program. The plantings that have survived in this area have become well established despite previous impacts from grazing native fauna.</p>	<p>Lantana (<i>Lantana camara</i>) was recorded growing intermittently throughout this zone, continue to control via cut and paint methods.</p> <p>Rhodes Grass (<i>Chloris gayana</i>), Spear thistle (<i>Cirsium vulgare</i>) and Cobblers Pegs (<i>Bidens pilosa</i>) were also recorded growing along the roadside.</p>

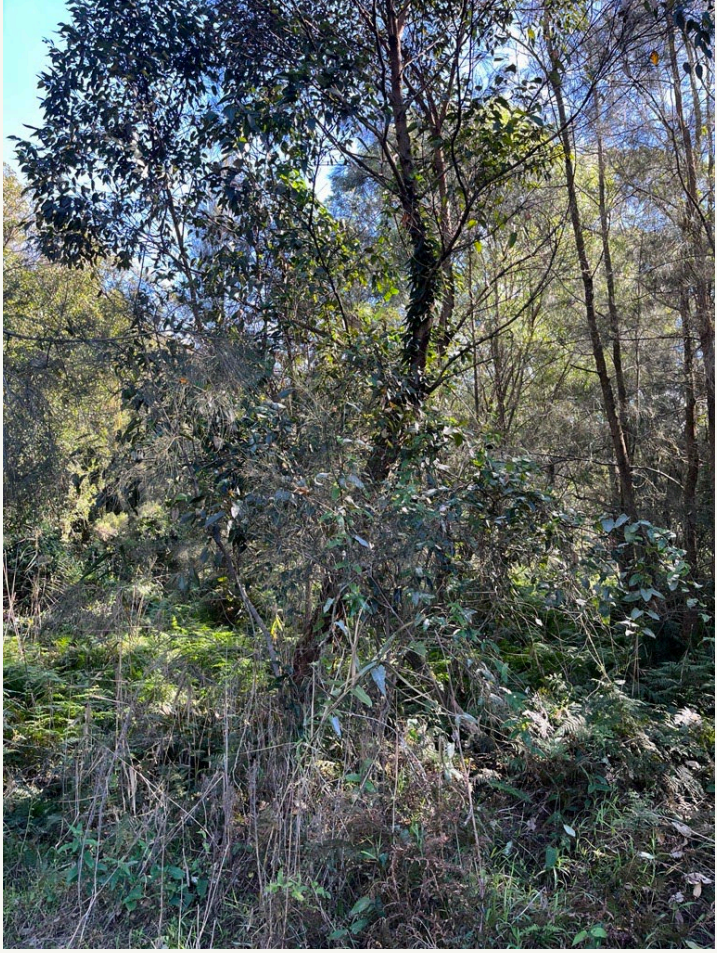
Zone	Location / description	Recommendations for ongoing works 2024/2025	Reference Images
<p>Subzone 2B.1</p>	<p>This subzone is a narrow area that was regenerated to link the creek-side forest to that within Zone 4. The subzone was spread with topsoil and timber debris, and plantings were undertaken. Considerable growth of the plantings has since been noted.</p>	<p>The vegetation within this subzone appears to be in good condition (pictured), however there is substantial Moth Vine (<i>Araujia sericifera</i>) and Giant Reed (<i>Arundo donax</i>) growth in places along the roadside. Both can be managed via cut and paint methods.</p> <p>Additionally, Cobblers Pegs (<i>Bidens pilosa</i>) and Spear thistle (<i>Cirsium vulgare</i>) were prominent along the edge of the road.</p>

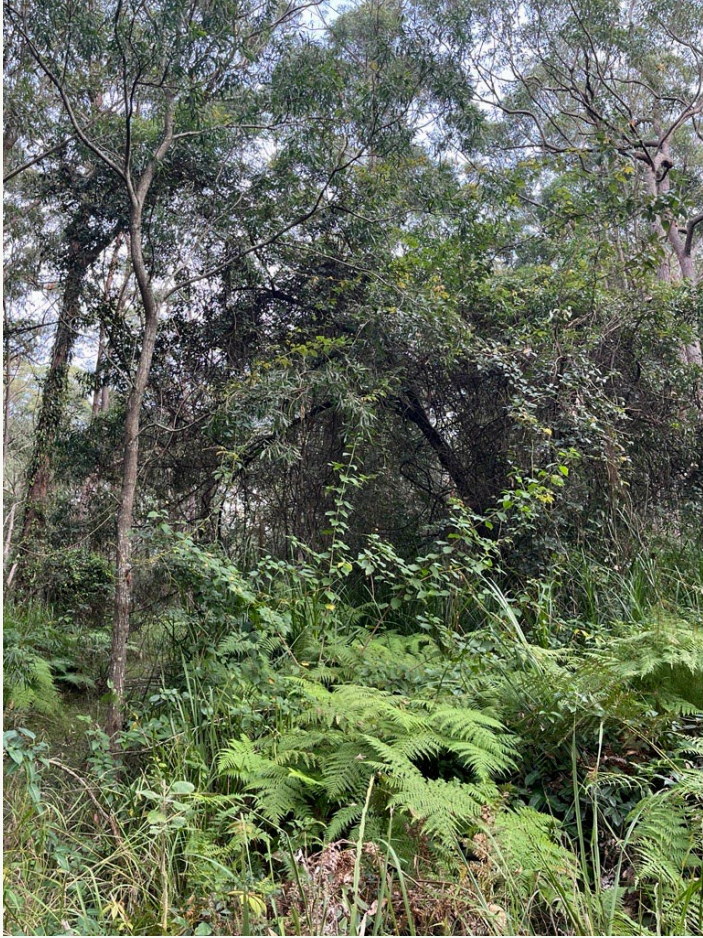
Zone	Location / description	Recommendations for ongoing works 2024/2025	Reference Images
Subzone 2B.2	<p>This area is located in a low-lying swamp and is being colonised by Swamp Oak. Some planting was carried out on a higher part of the subzone in the south and west in previous years (KMA 2018). The natural regeneration occurring in this subzone is adequate.</p>	<p>This subzone appears to be high condition vegetation, largely made up of native ferns. There is some Lantana (<i>Lantana camara</i>) encroachment (pictured). This should be managed via cut and paint methods. Tobacco Plant (<i>Solanum mauritianum</i>) was also recorded sporadically along the roadside.</p> <p>At the western end of this subzone, Giant Reed (<i>Arundo donax</i>) and Pigeon Grass (<i>Setaria parviflora</i>) were also recorded. It was noted that some plantings were dead, however majority have matured nicely.</p>

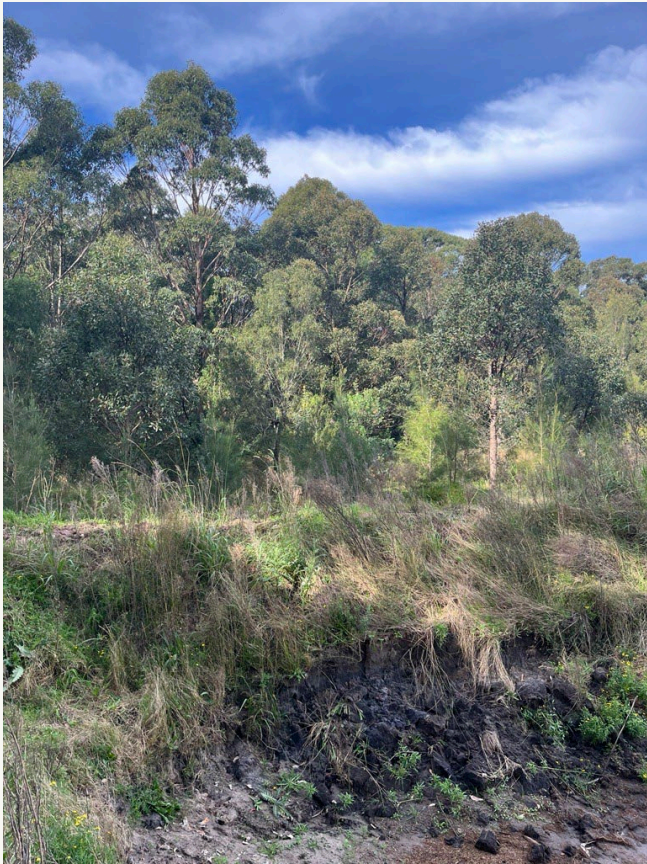
Zone	Location / description	Recommendations for ongoing works 2024/2025	Reference Images
Subzone 2C.1 (northern end)	This subzone is known as 'The Garden' and is a planted area adjacent to more established vegetation located in subzone 1.1.	<p>'The Garden' appears to be in good condition, plantings are now well established, and the area is generally free from high threat weeds. Infill plantings are suggested to promote native tree and shrub growth and to lessen risk of weed reinvasion.</p> <p>Occurrence of weeds is concentrated around the bank of the dredge pond (pictured) and species include Flaxleaf Fleabane (<i>Conyza bonariensis</i>), Fireweed (<i>Senecio madagascariensis</i>) and Spear Thistle (<i>Cirsium vulgare</i>).</p>

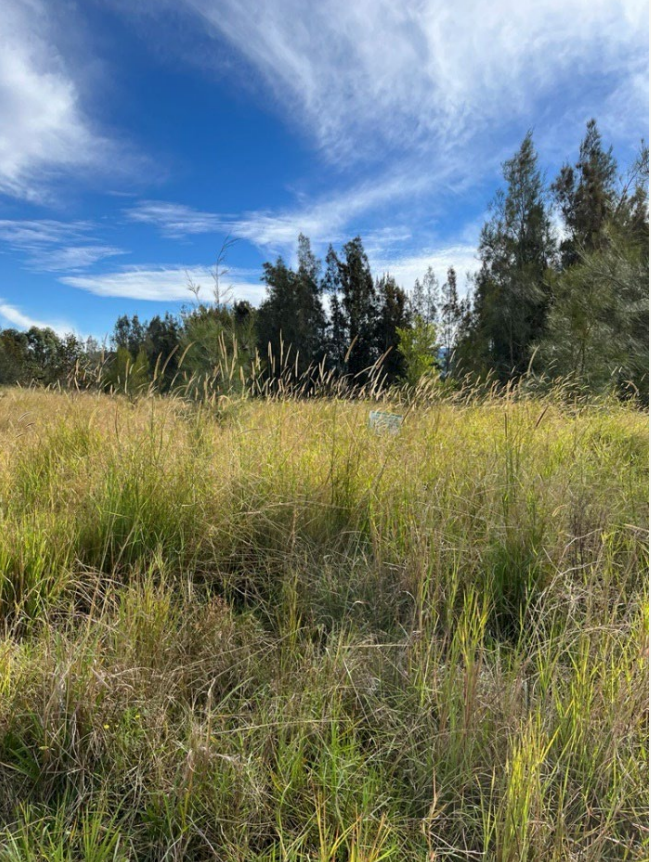
Zone	Location / description	Recommendations for ongoing works 2024/2025	Reference Images
Subzone 2C.2	A long narrow area supporting some well-established plantings.	<p>At western end, Swamp Oak (<i>Casuarina glauca</i>) plantings are very well established. Weeds are very sparse.</p> <p>A high cover of weeds was observed in the eastern end near 2B.2 (pictured) with species such as Pigeon Grass (<i>Setaria parviflora</i>), Fireweed (<i>Senecio madagascariensis</i>) and Purpletop Vervain (<i>Verbena bonariensis</i>) dominating the area.</p>

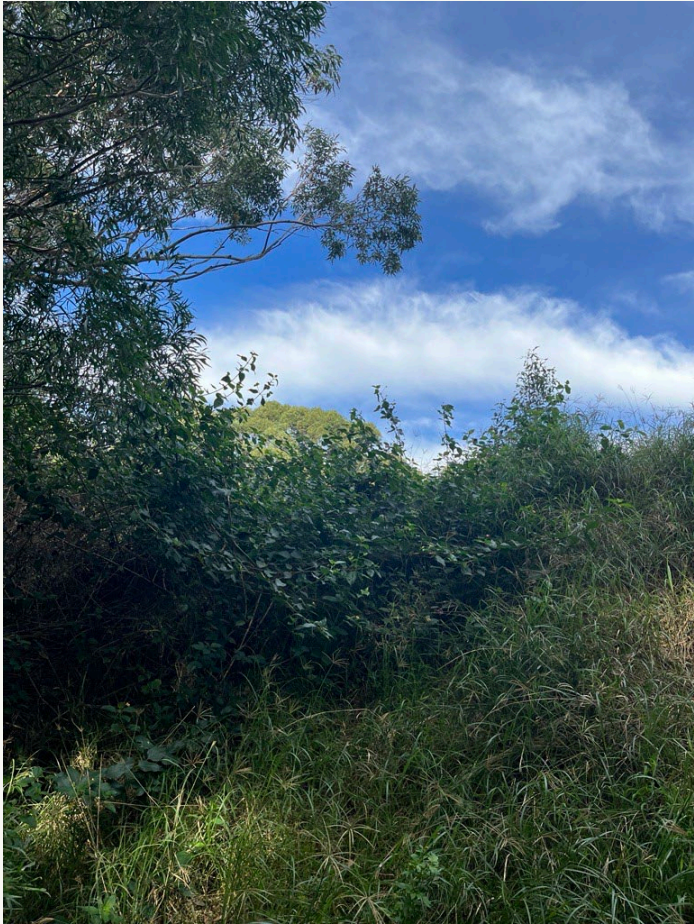
Zone	Location / description	Recommendations for ongoing works 2024/2025	Reference Images
Zone 3	<p>This zone includes the bund wall which reached its final height early in 2015. A screen of native vegetation was established along the eastern edge of the pond extension. The sand bund is currently stabilised by growth of plants, the majority of which are weeds.</p>	<p>Similarly to previous years, large stands of Lantana (<i>Lantana camara</i>) persist along the bund wall (pictured). Continue removal of the Lantana using cut and paint methods. Planting is required to encourage native growth and to stabilise the bund wall.</p> <p>Additional weeds recorded along the edge of the bund wall within zone 3 include Cobblers Pegs (<i>Bidens pilosa</i>), Rhodes Grass (<i>Chloris gayana</i>), Fireweed (<i>Senecio madagascariensis</i>) and White Passionflower (<i>Passiflora subpeltata</i>) (Plate 6).</p>

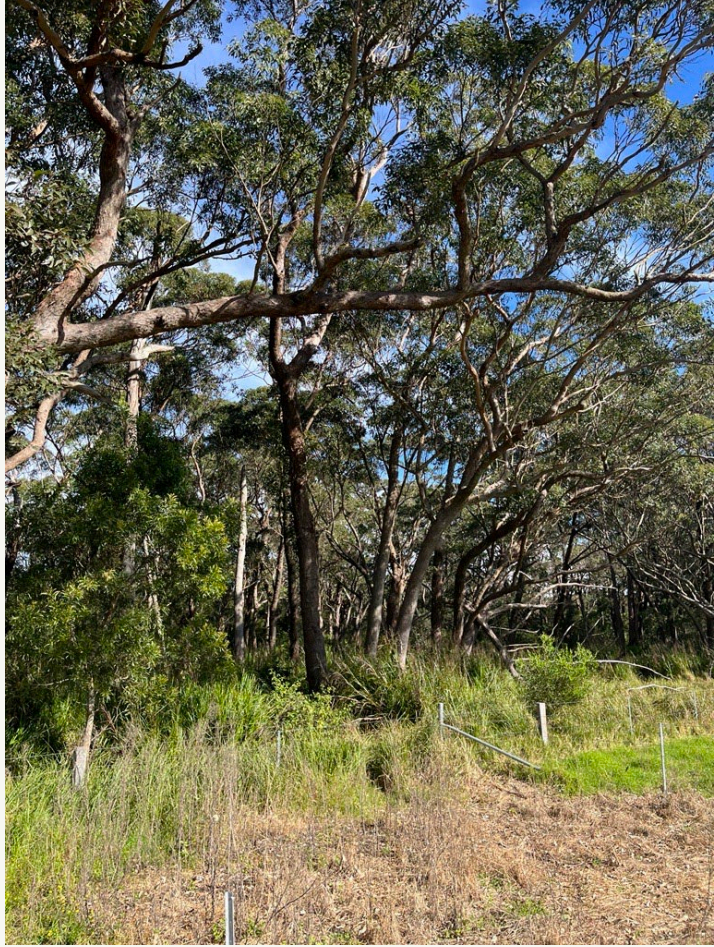
Zone	Location / description	Recommendations for ongoing works 2024/2025	Reference Images
<p>Zone 4</p>	<p>This zone is remnant Bangalay Sand Forest vegetation. This area has an intact Bangalay and Blackbutt canopy and is of high habitat value. Lantana has been heavily targeted in this zone and continued maintenance has been completed.</p>	<p>The woodland appears to be in good condition (pictured). Fireweed (<i>Senecio madagascariensis</i>) is prevalent along the fence line, however there are minimal weeds within the woodland.</p> <p>A dense infestation of weeds, primarily Fireweed (<i>Senecio madagascariensis</i>) and Common thornapple (<i>Datura stramonium</i>), was recorded along the top of the dirt mound outside the fence line. Not part of this zone, however, monitor weeds for encroachment into zone 4.</p>

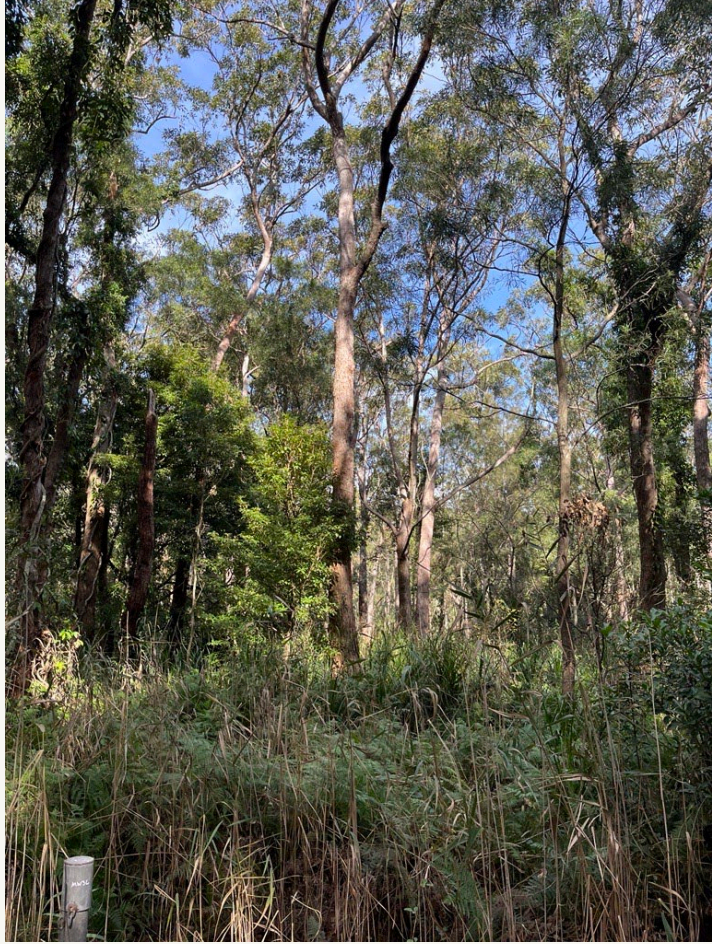
Zone	Location / description	Recommendations for ongoing works 2024/2025	Reference Images
Zone 6	<p>This zone occurs within the foreshore areas of the Dredge Pond. The foreshore has been previously shaped, had topsoil spread and planted as the dredge pond has expanded northwards. Overall, the pond bank is stable with little to no erosion evident. Natural regeneration and pre-existing native growth have helped to stabilise area.</p>	<p>This zone appears to be in relatively high condition. There is Giant Reed (<i>Arundo donax</i>) intermittently growing along the roadside (pictured), and some small Lantana (<i>Lantana camara</i>) stands, which can both be managed via cut and paint methods.</p> <p>Along the bank, avoid spraying to ensure native species retain dredge pond bank stability. Additional plantings may be beneficial to encourage native growth and to control herbaceous weeds such as Fireweed (<i>Senecio madagascariensis</i>) and invasive grasses from dominating.</p>

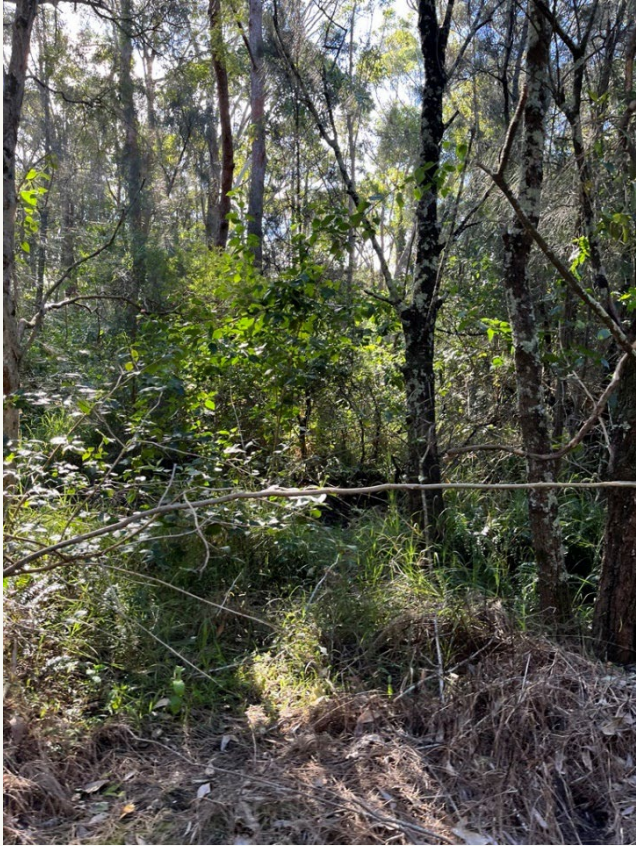
Zone	Location / description	Recommendations for ongoing works 2024/2025	Reference Images
Zone 7	This zone occurs along the eastern edge of the Site between zones 3 and 1.2. This zone has cultural significance, therefore only minor control of Lantana has been conducted over time.	This zone appears to be in a similar condition to subzone 1.2. Dense Lantana (<i>Lantana camara</i>) was observed throughout (pictured) and should continue to be monitored and removed via cut and paint methods.

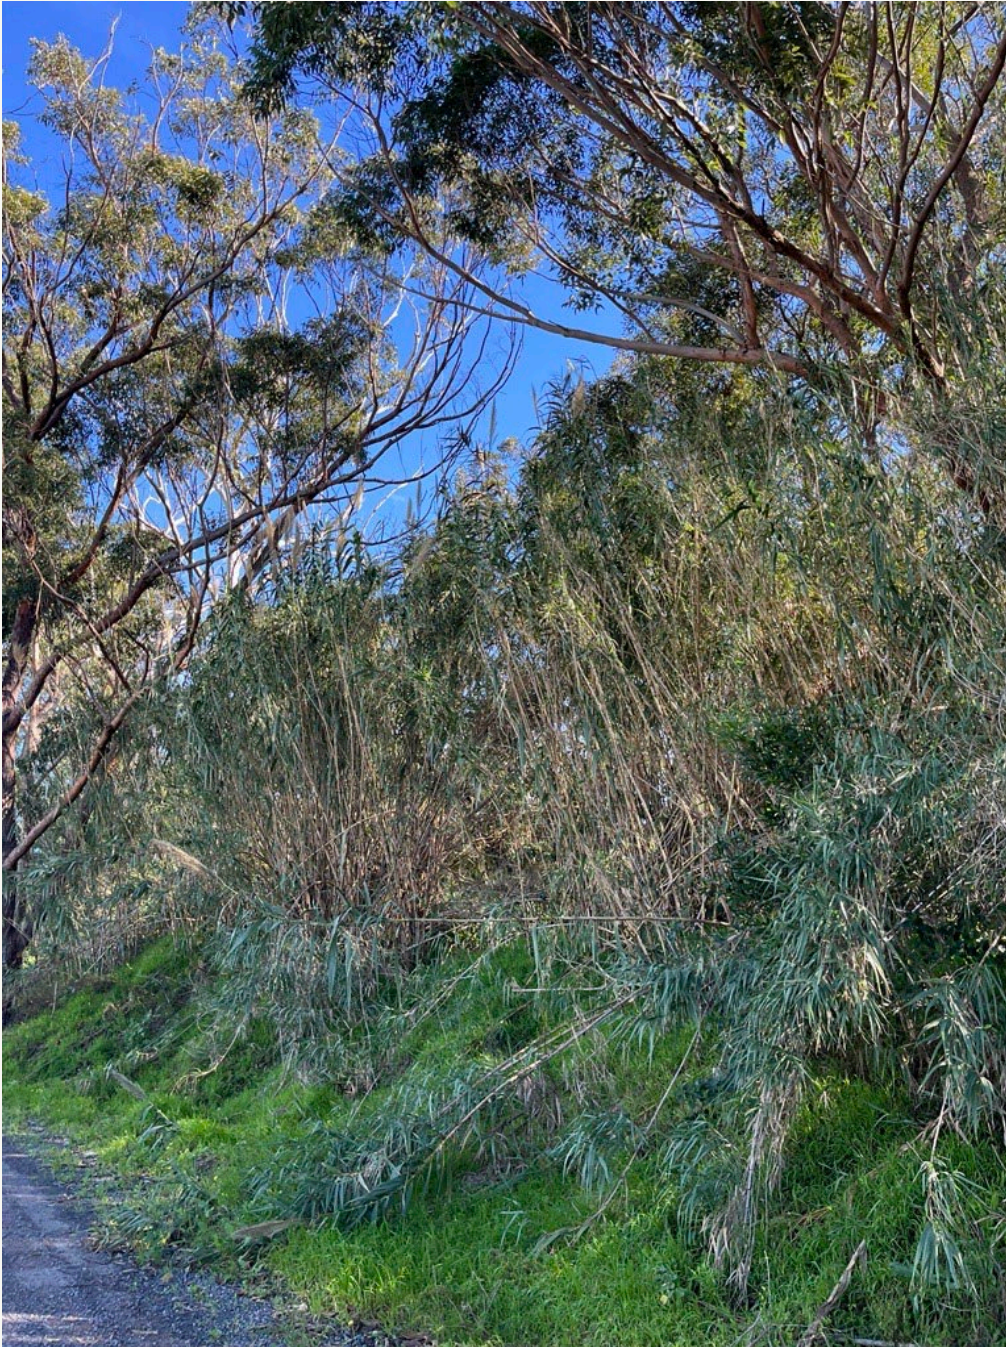
Plate 1: Giant Reed (*Arundo donax*) growing along the roadside of Subzone 1.1

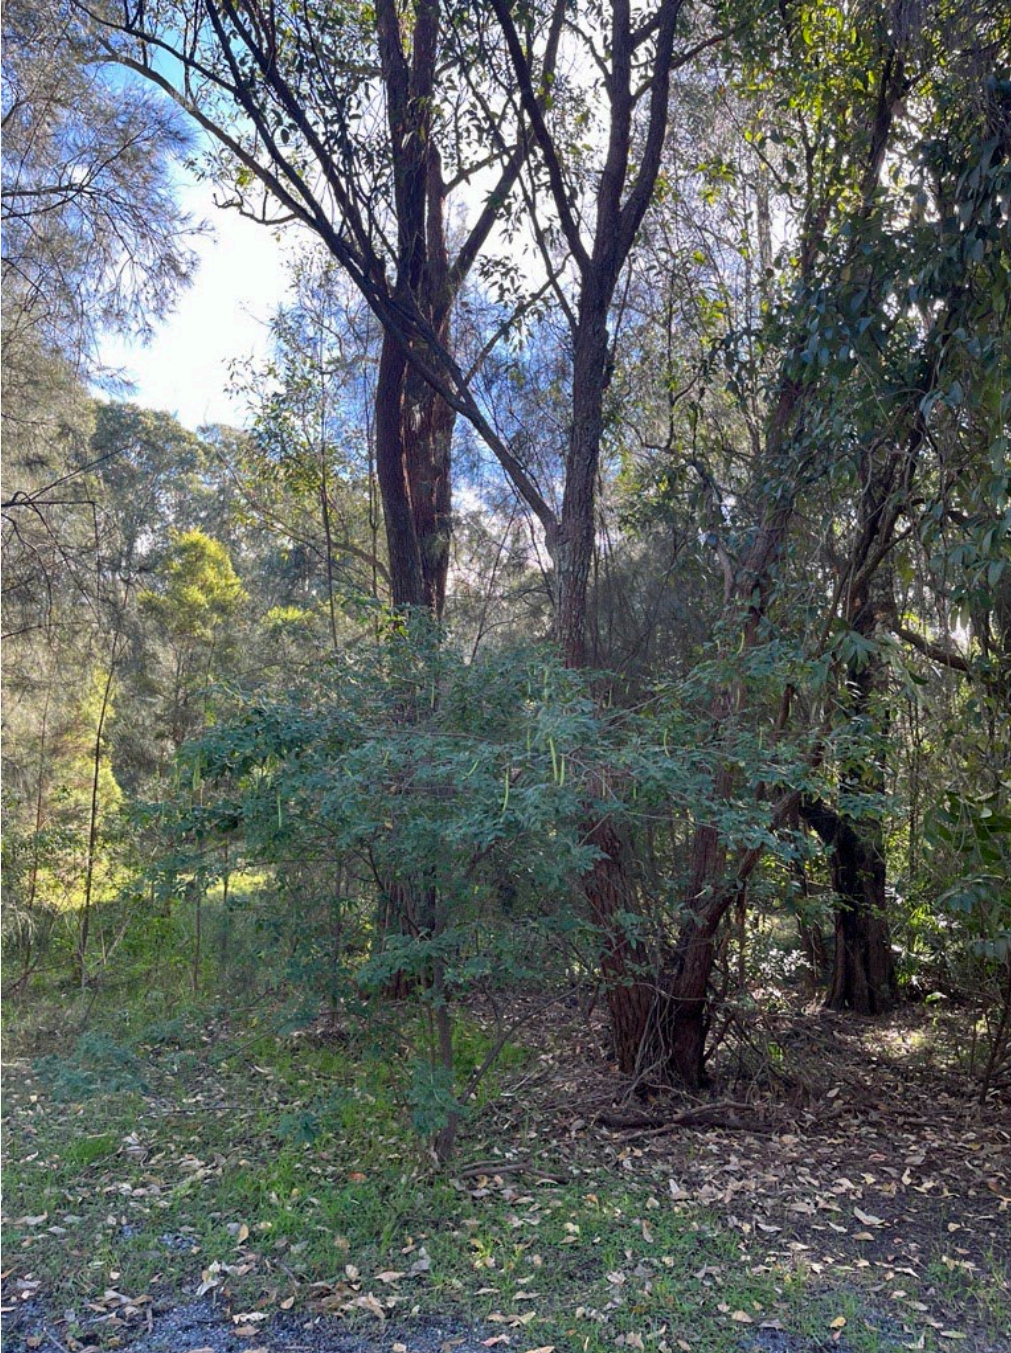
Plate 2: Cassia (*Senna pendula*) growing near office in Subzone 1.2

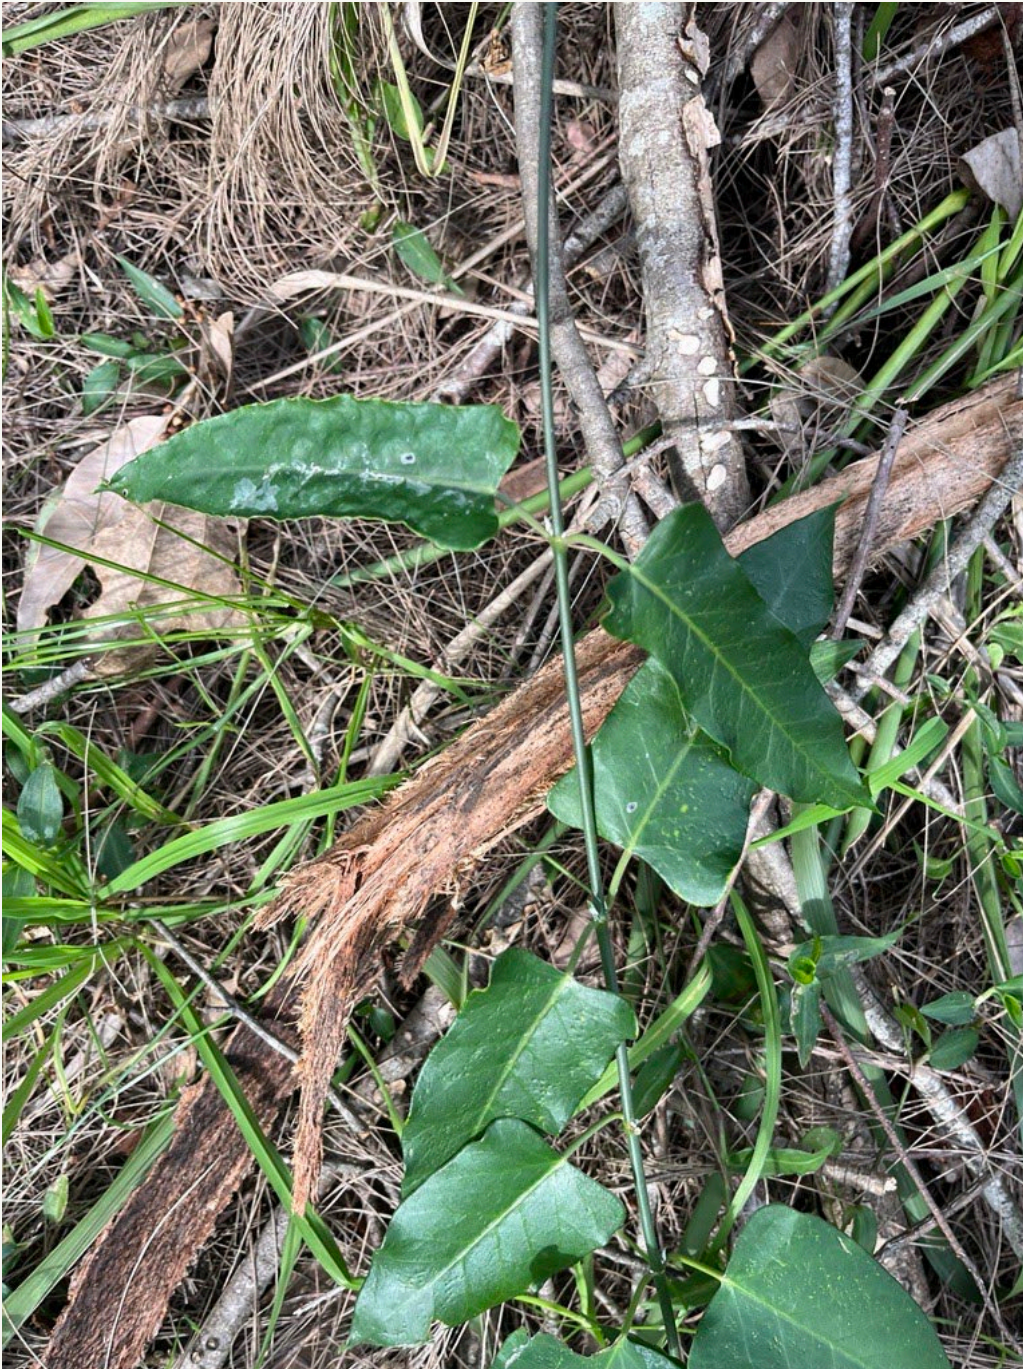
Plate 3: Moth Vine (*Araujia sericifera*) found within Subzone 1.3

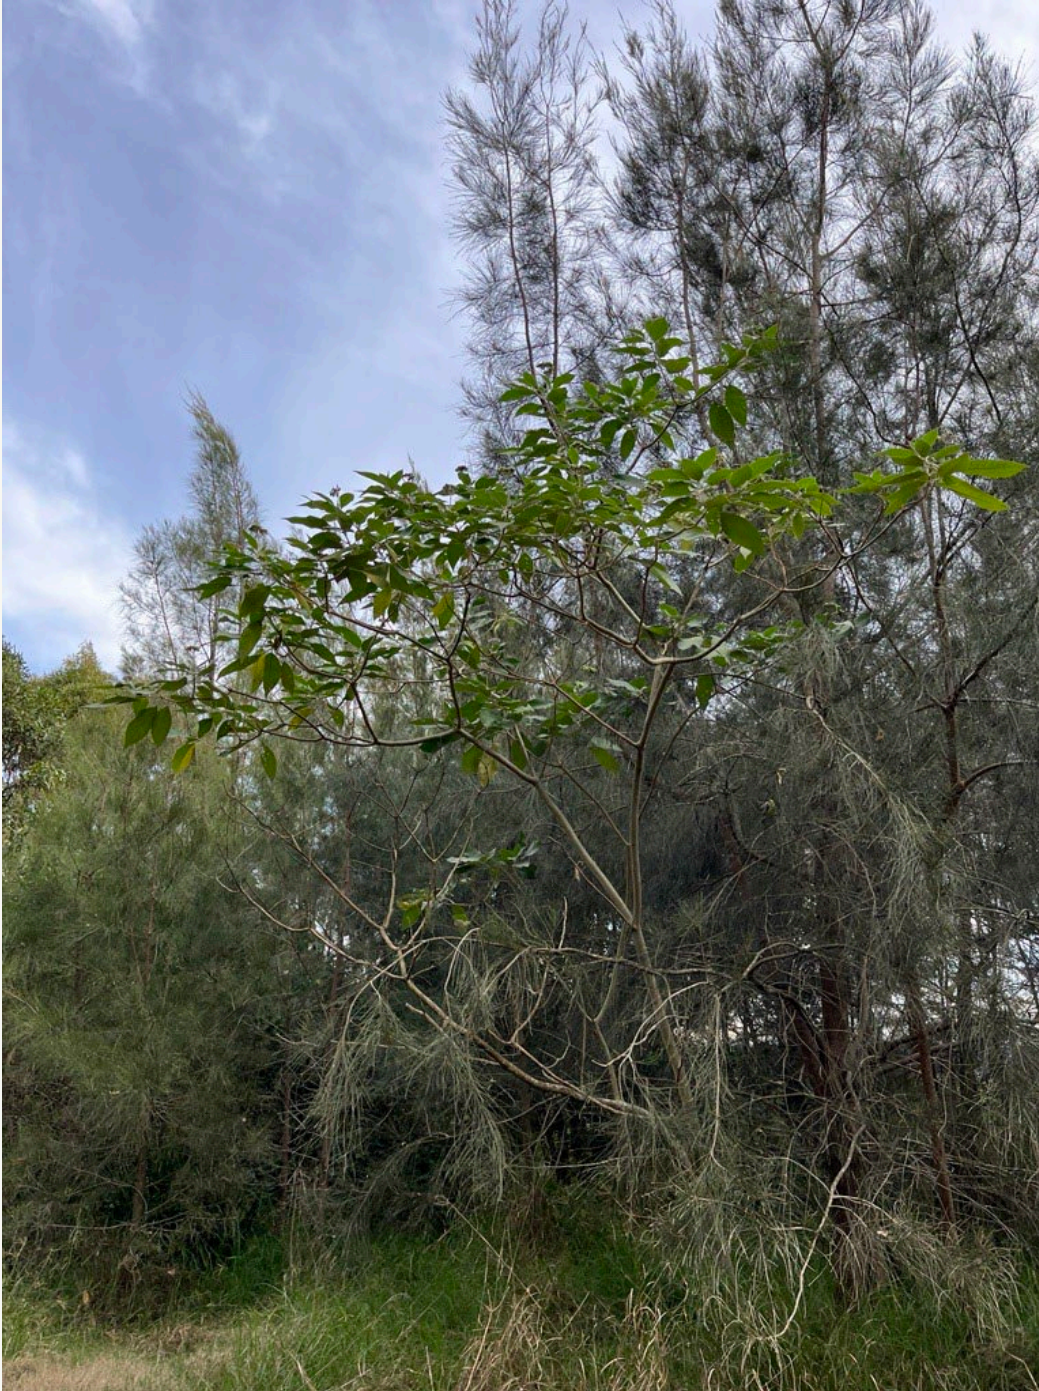
Plate 4: Tall Tobacco plant (*Solanum mauritianum*) found within Subzone 2A.2

To improve revegetation successes, such as those exhibited in the northern portions of the Gerroa Sand Quarry, mature weeds such as Wild Tobacco Bush (found in Zone 2A.1, 2A.2, 2B.2 and 2D) and Lantana stands (found in most zones) should be targeted to limit further seed dispersal given their higher fecundity. Weed removal should be undertaken using cut and paint methods for these woody weeds since it offers a higher kill rate and avoids indirect poisoning of adjacent native species.

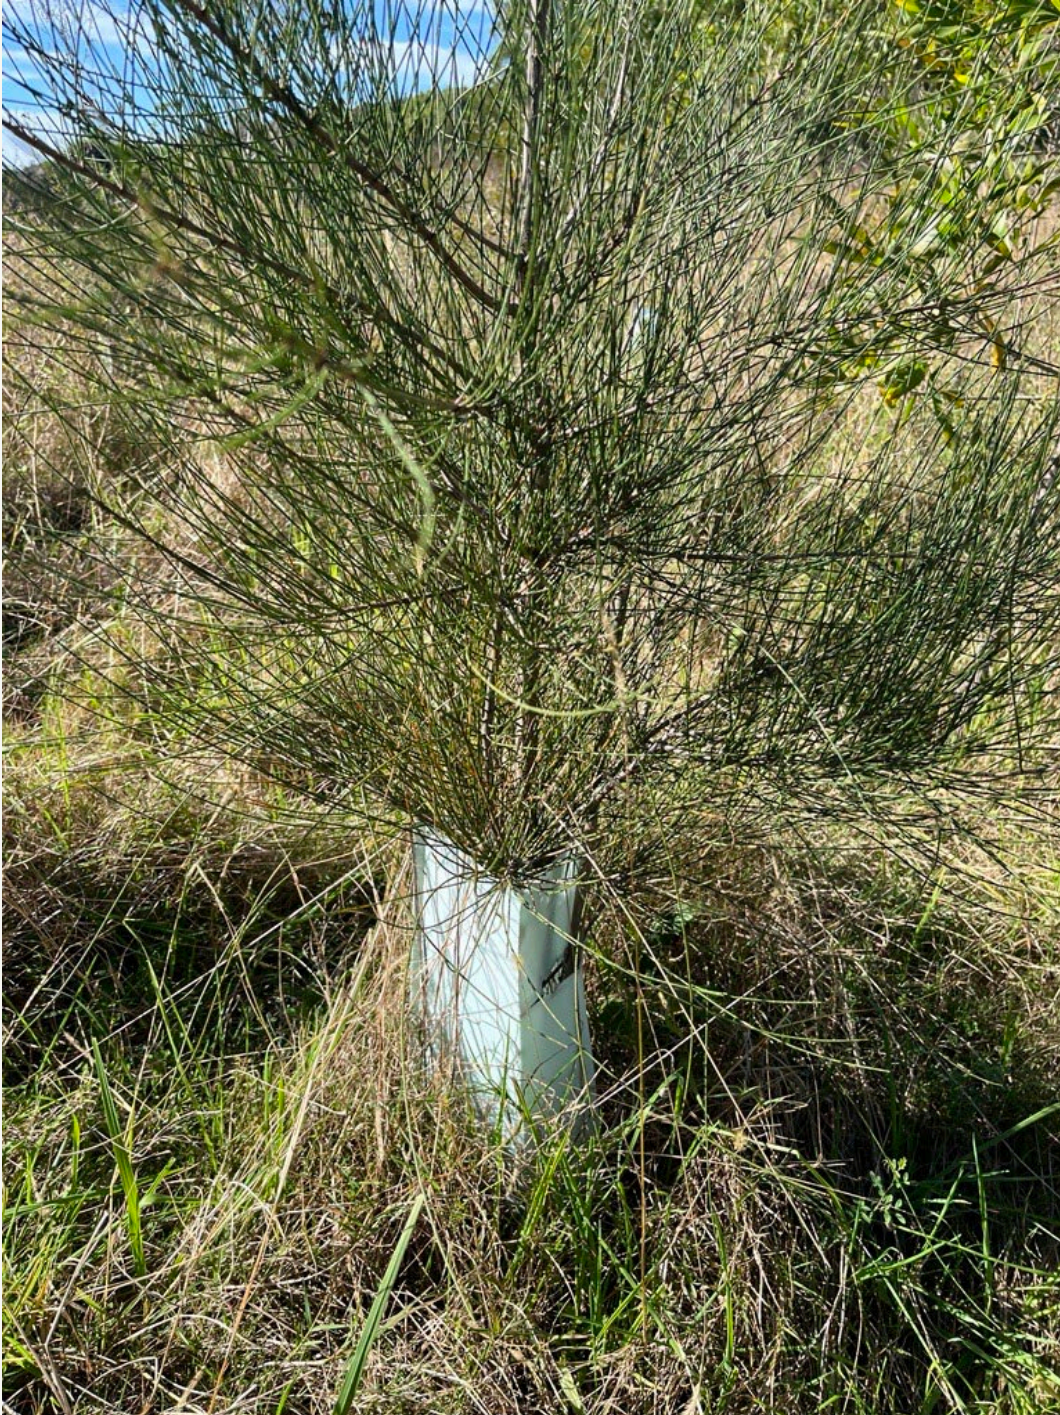
Plate 5: Swamp Oak (*Casuarina glauca*) planting with tree guard still in place, Subzone 2C.1 (southern end)

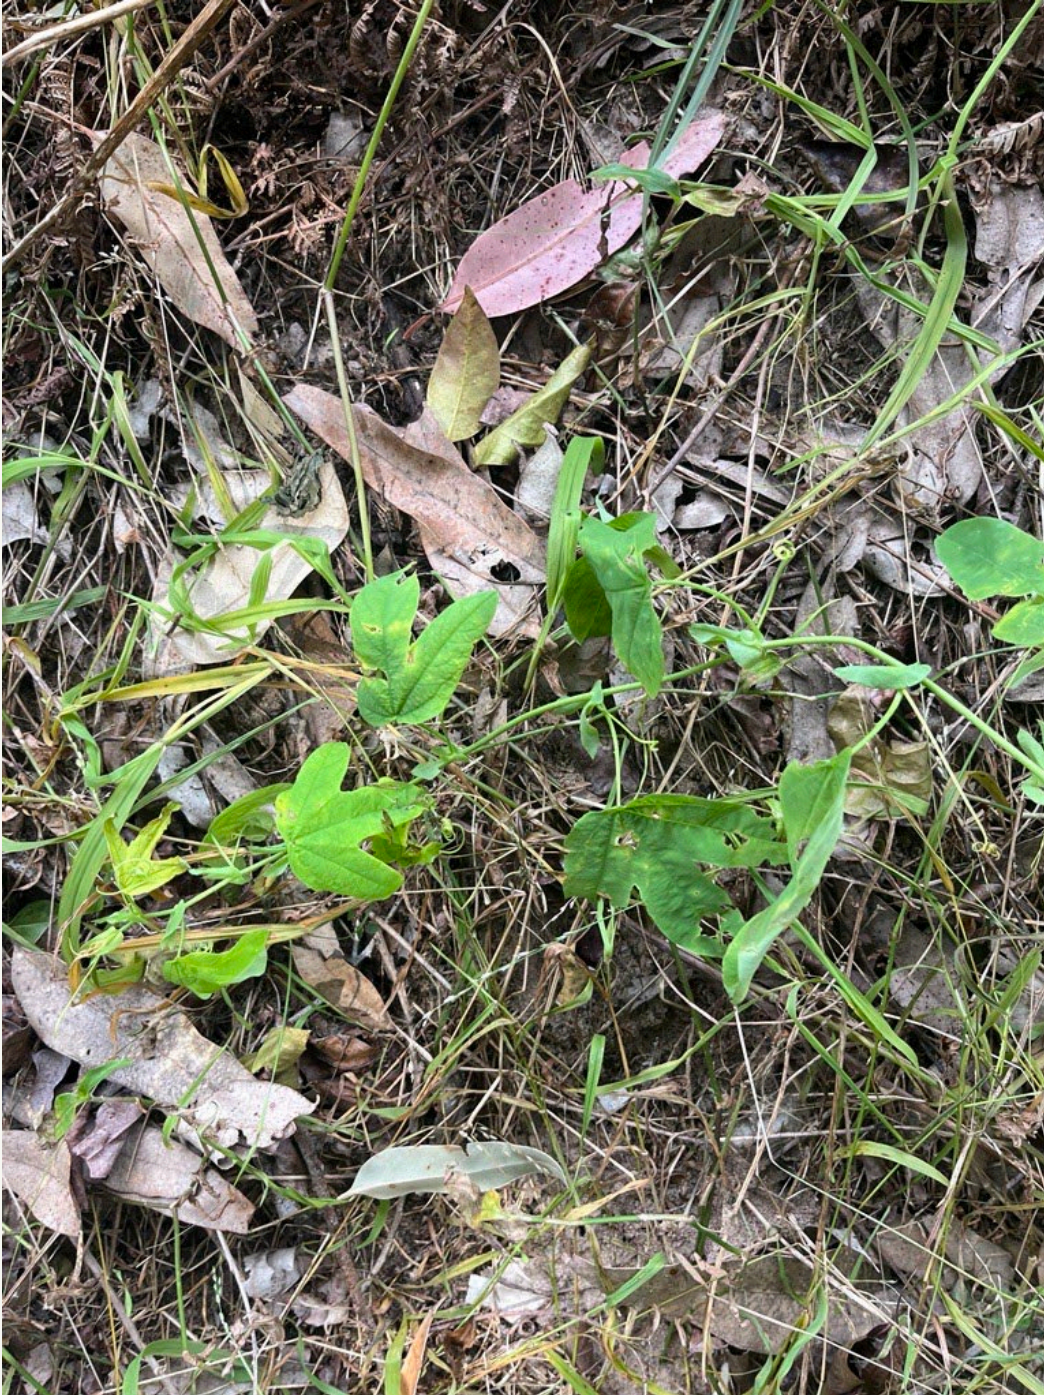
Plate 6: White Passionflower (*Passiflora subpeltata*) growing along the bund wall in Zone 3
